### REQUEST FOR EGLE REVIEW OF RESPONSE ACTIVITY PLAN

This Plan is for evaluating the volatilization to indoor air pathway (VIAP) and assessing the electrical panel area

Facility Name: Phase 1A &amp; 1B of Proposed Parkside Village County: Kent

# RESPONSE ACTIVITY PLAN - EVALUATION PLAN

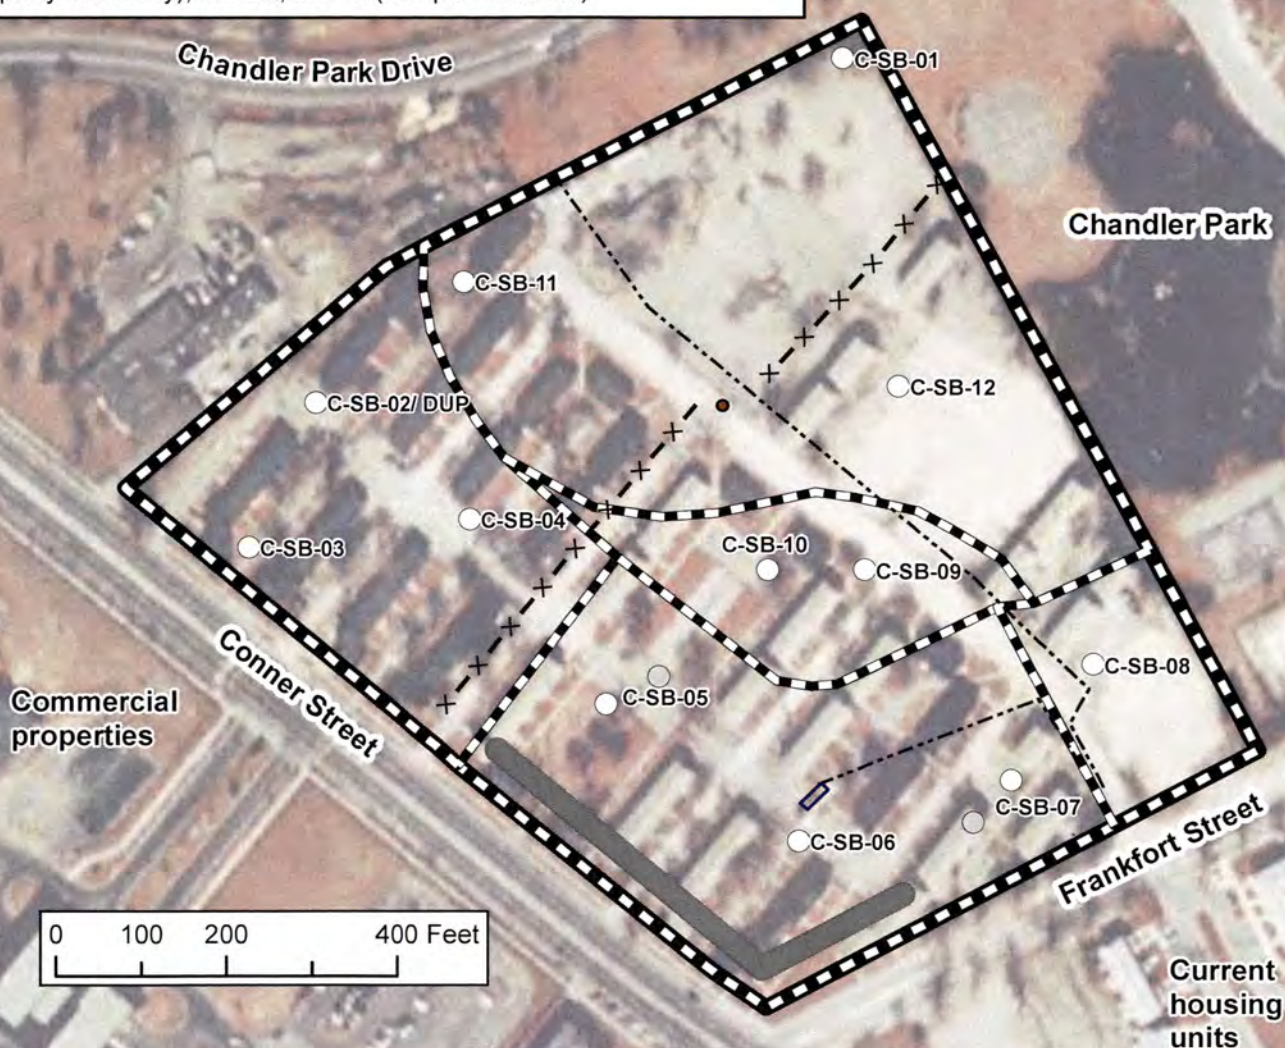
Sources: MIS - Michigan Imagery Solution WMS Services (1998 aerial image); Detroit Housing Commission (Property boundary); MDEQ, 2014b (sample locations)

- Soil Boring sample, planned and collected (unless moved during fieldwork)
- Soil Boring sample, after moving its location during fieldwork
- Decision Unit boundaries
- Conner Property boundary
